RAIL INVESTIGATION REPORT

**Collision between the passenger  
train 5AL8 and vehicles at the  
Salisbury Interchange level crossing,  
Salisbury, South Australia**

**24 October 2002**

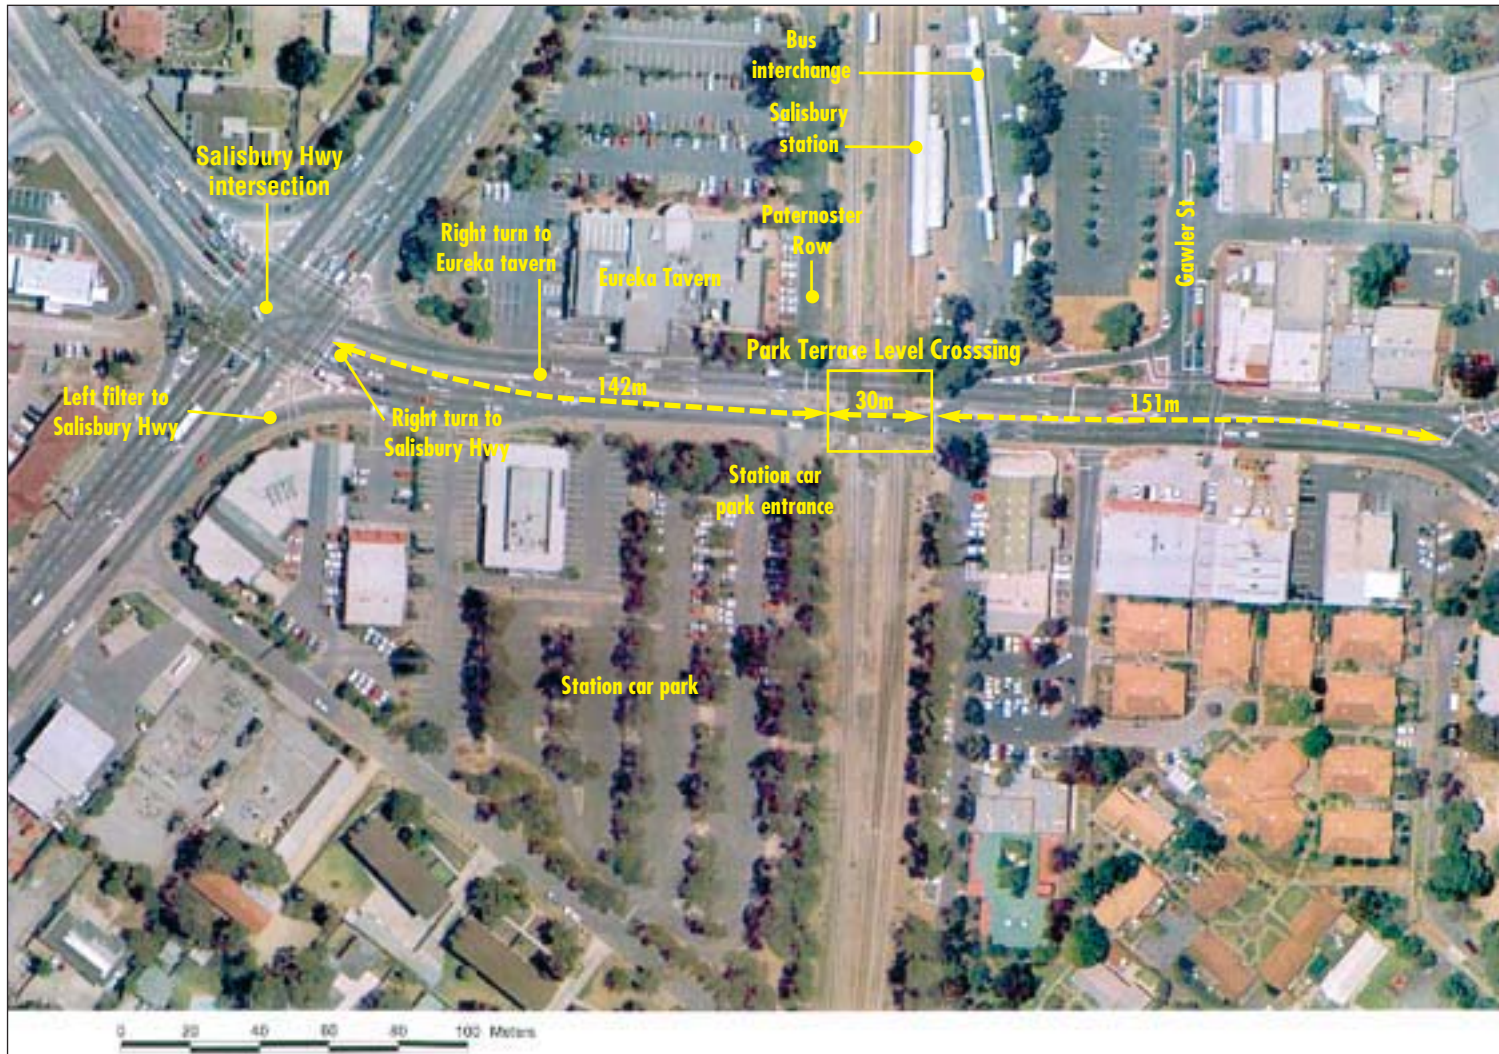
**FIGURE 2:**  
**Park Terrace - Level Crossing and road alignment**

or turn left into the Eureka Tavern, or Paternoster Row or right (across the west-bound stream) into the station car park. Once across the rail crossing there is a right turn lane to North Lane and a left turn lane into Gawler Street and the retail and civic complex. Eastbound traffic remains on Park Terrace or turns left under signal control into Wiltshire Street.

To the east, the junction of Wiltshire Street and Park Terrace is controlled by traffic lights comprising a set of 15 vehicle lanterns and 6 pedestrian lanterns positioned on 10 traffic light poles. For traffic approaching from the eastern part of Park Terrace there is a right turn lane into Gawler Street and a left turn into North Lane. Once across the railway crossing travelling west there is a left turn into the station car park and a left turn lane into Salisbury Highway, two lanes for traffic going straight ahead and a right turn lane.
